PROPERTY INSPECTION REPORT

FOUNDATION: SLAB-ON-GRADE FREE STANDING – MONOLITHIC (POST-TENSION)	
GUIDE: STORY: NA	HOUSE: RESIDENTIAL-SINGLE FAMILY DWELLING
BEDROOM: NA	BATH: NA GARAGE:
YEAR BUILT: 2017	SQFT: 4200+/-
TIME: 11:00 AM	PRESENT: SUPERINTENDENT REALTOR -

FOUNDATION: SLAB-ON-GRADE FREE STANDING – MONOLITHIC (POST-TENSION)

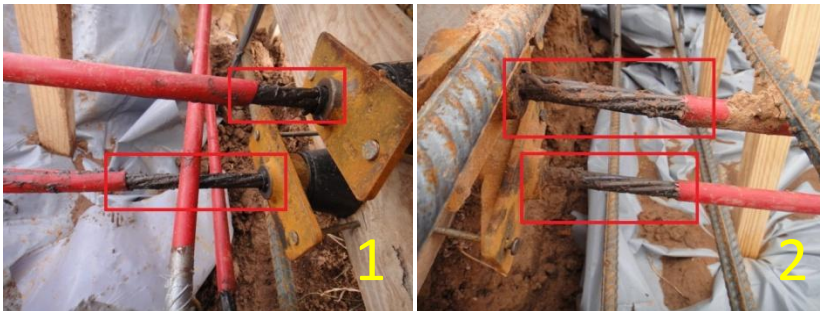
- All breaks, tears, rips (damaged areas or voids) in the Post-Tensioning tendon sheathing material shall be repaired with tape prior to concrete placement. PTI (Post Tensioning Institute) approves these tapes/materials: (Photo 1, 2)(Throughout)
1. Polyken #900 (2" wide) General utility pipeline tape
 2. 3M Scotch Brand # 481 preservation sealing tape
 3. 3M Scotch brand #226 black polyethylene masking tape
 4. Tape Specialties Limited #355 PVC tape
 5. Wimmore tape # 413 (PVC pipe wrap tape)
 6. Polyken #223 waterproof duct tape

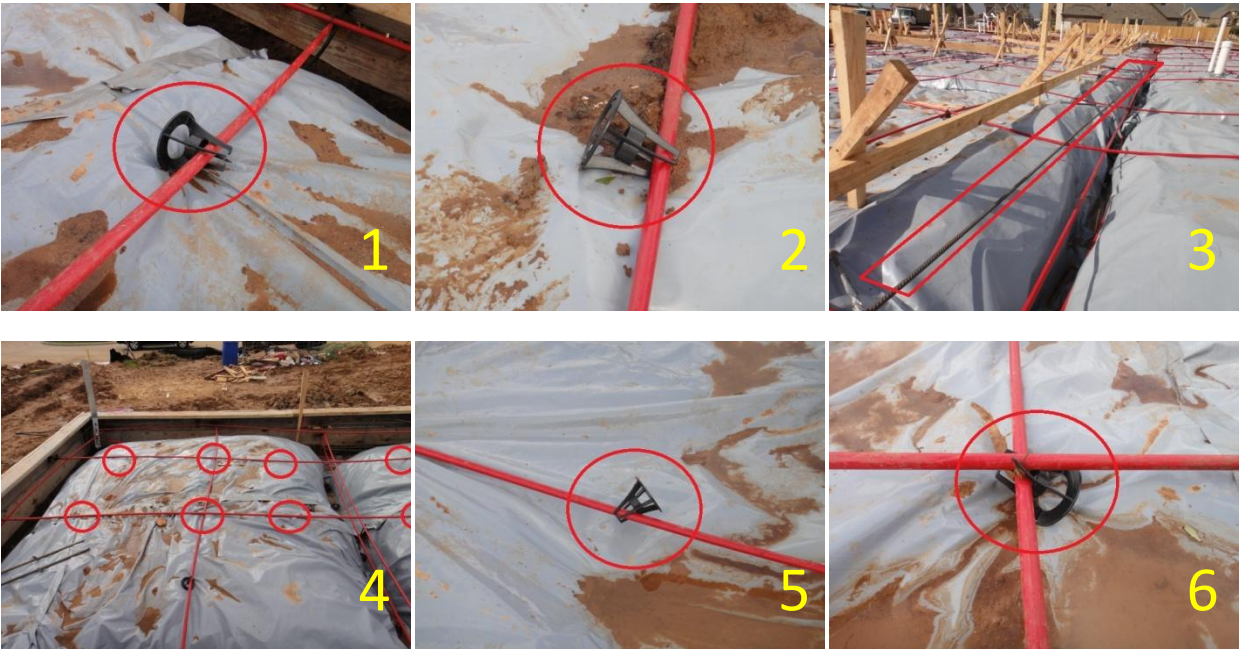
- Chairs to post tension cables and metal rebars should be supporting the cables. Service/repair cable/rebar chairs throughout.
(Photo 1, 2, 3, 4, 5, 6)

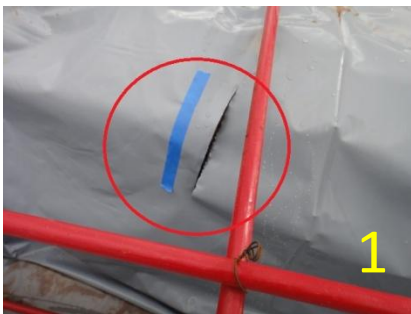
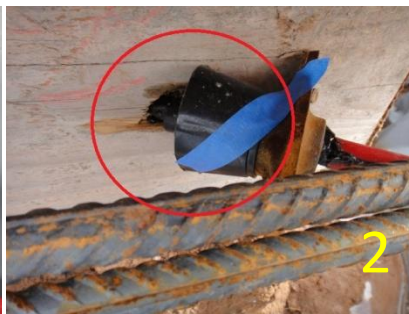
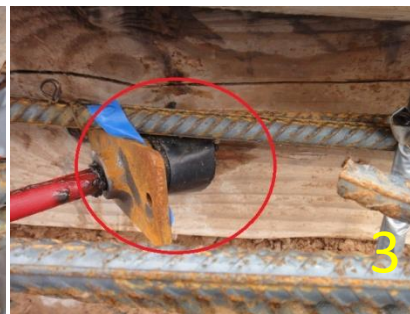
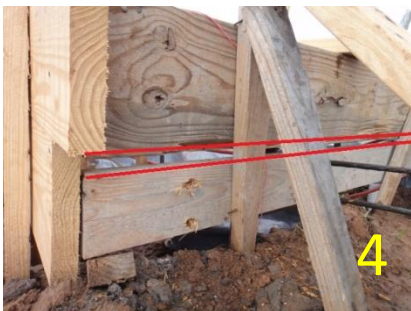
- To prevent cement slurry from entering below vapor barriers, all tears, holes, and open seams in the vapor barrier must be patched and repaired with approved tape. Sheathing must properly overlap and be secured.
(Photo 1)
- 1. Polyken #900 (2" wide) General utility pipeline tape
- 2. 3M Scotch Brand # 481 preservation sealing tape
- 3. 3M Scotch brand #226 black polyethylene masking tape
- 4. Tape Specialties Limited #355 PVC tape
- 5. Wimmore tape # 413 (PVC pipe wrap tape)
- 6. Polyken #223 waterproof duct tape
- Observed gap between wedge formers and form board to bay window at rear, recommend replacing the plastic wedge formers to approved / angled wedge former.
(Photo 2, 3)
- Observed gap between the wood form board at front right corner, the cement slurry will leak out and or not form a smooth facing on the perimeter beam facing.
(Photo 4)

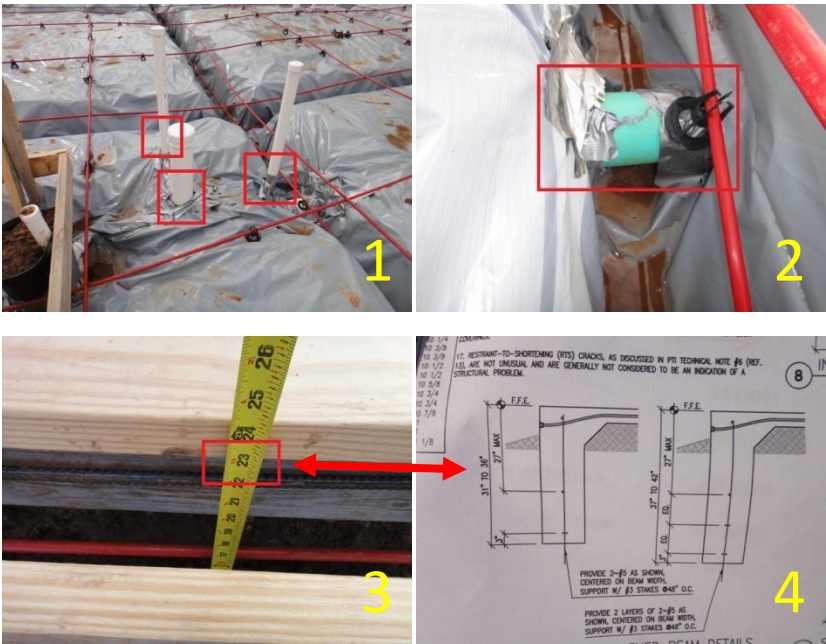
- Apply protective coating and or mastic seal to all drain and sewer pipes at this time. (Photo 1, 2)
- Observed only 23” or less to perimeter foundation beam depth throughout, per foundation schedule a 31”-42” depth is required, recommend contacting a professional engineer or structural foundation specialist to evaluate at this time. The perimeter foundation footing was observed with loose soil and back filled during rain storm throughout, recommend repairing / digging out the depth to foundation schedule. (Photo 3, 4)

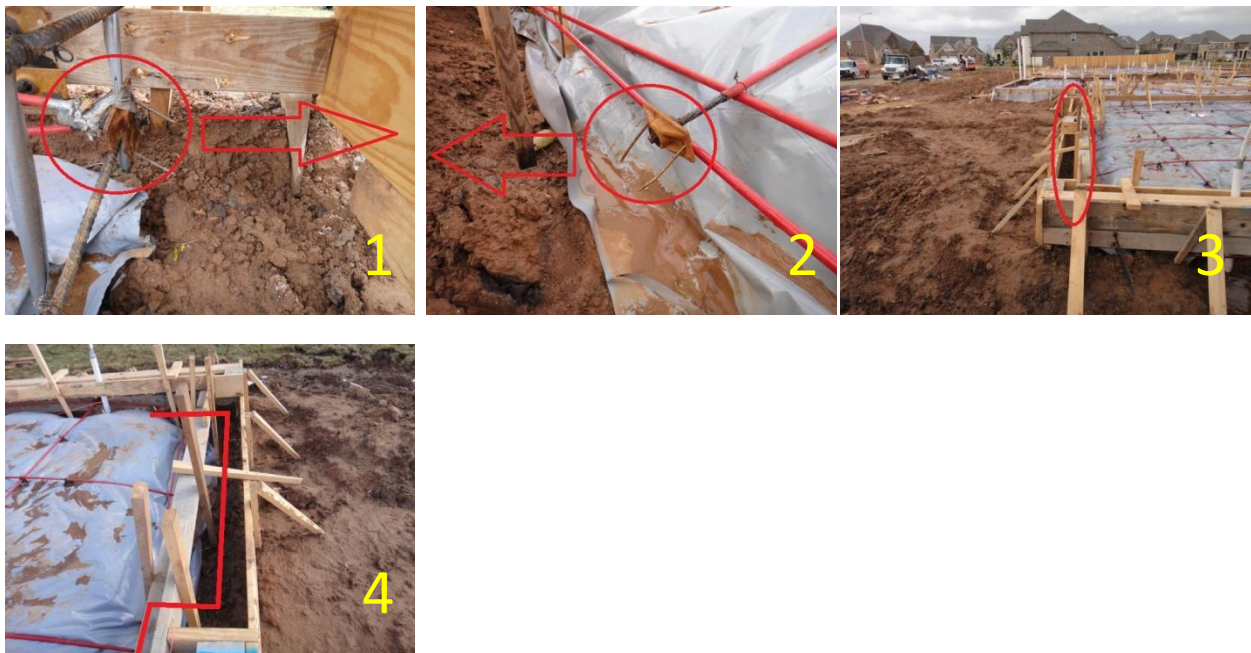
- Tension cables at front were improperly installed to form board, these cables should be fastened securely to wood form board prior to pouring the cement foundation, service/repair as needed.
(Photo 1, 2, 3)
- Metal rebars were missing to perimeter footing at front, service/repair as needed.
(Photo 4)

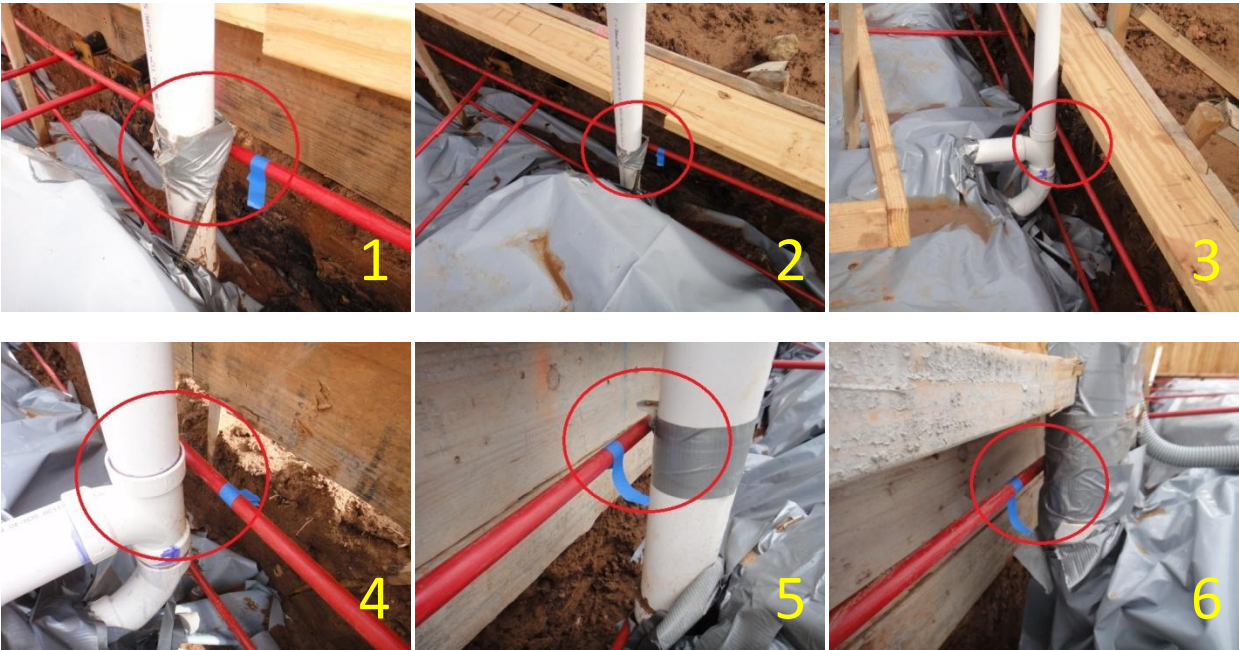
- Proper clearances between post tensioning cables and drain waste pipes not observed, provide/install/secure/align chairs as needed to attain proper clearances. (Photo 1, 2, 3, 4, 5, 6)(Throughout)

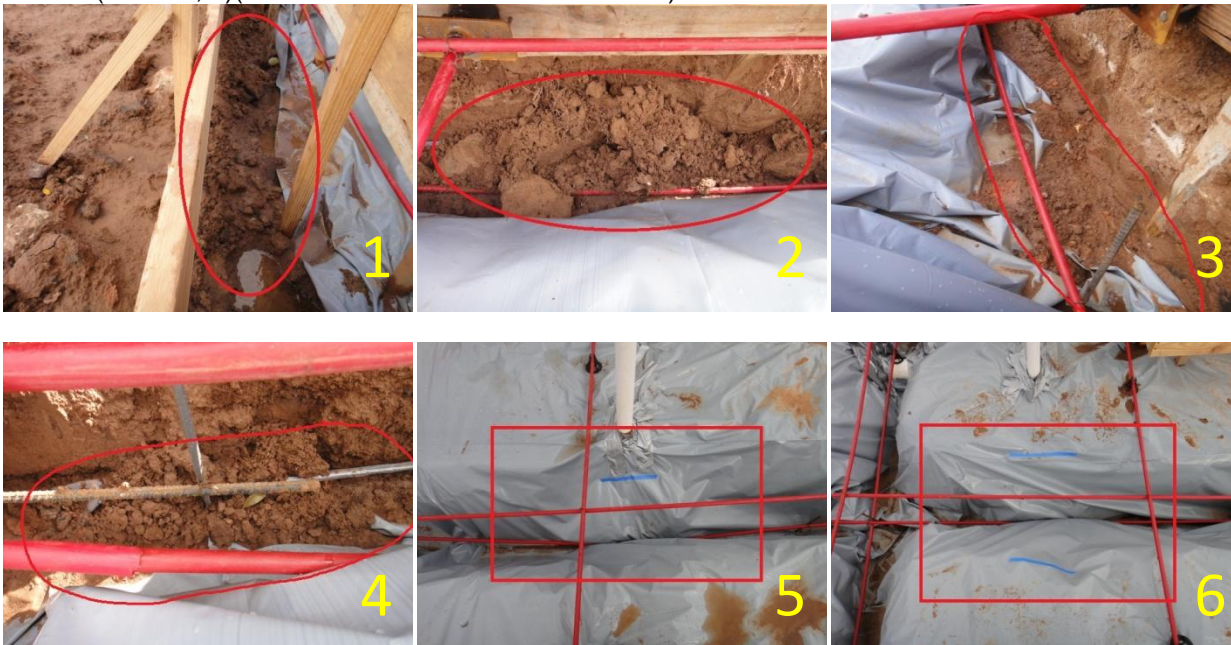
- The grading near perimeter footing is such that less than the minimum required 12" of undisturbed soil will be supporting the footing there. IRC 403.4.1 specifically requires that this be improved. (Photo 1)(Throughout)
- Prior to pouring the foundation slab, dirt, debris, and standing water to footings must be removed. (Photo 2, 3, 4)(Throughout)
- Service/repair the collapsed or loosely packed dirt forms as needed. (Photo 5, 6)(Center-near master bathroom areas)
