PROPERTY INSPECTION REPORT

FOUNDATION: SLAB-ON-GRADE FREE STANDING – MONOLITHIC (POST-TENSION)

NOTES: PRE-SHEETROCK INSPECTION

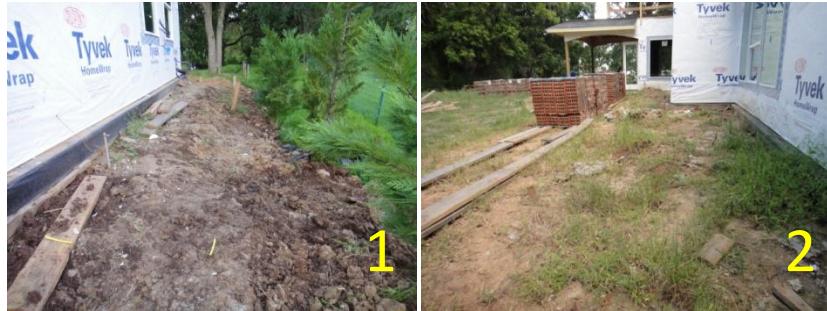
- Notes: The grading to property at this time was not complete, high grading/unlevel slopes and standing water on the grading near the cement foundation slab should be serviced and adjusted during final phase construction.
(Photo 1, 2)

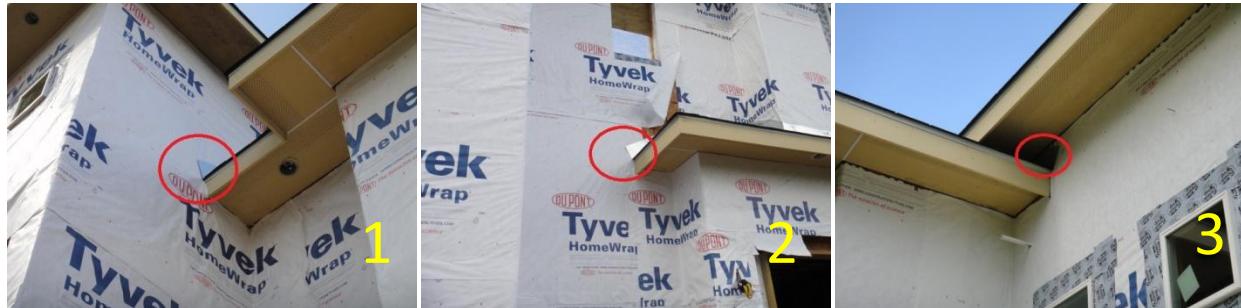
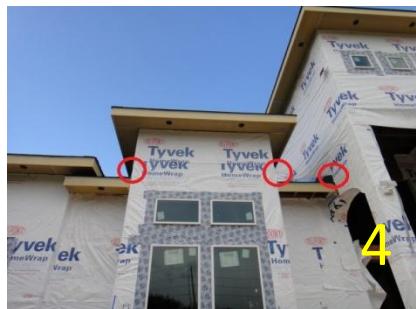
- Observed missing kickout flashing on roof covering/wall connections throughout, service/repair/install as needed.
(Photo 1, 2, 3, 4)

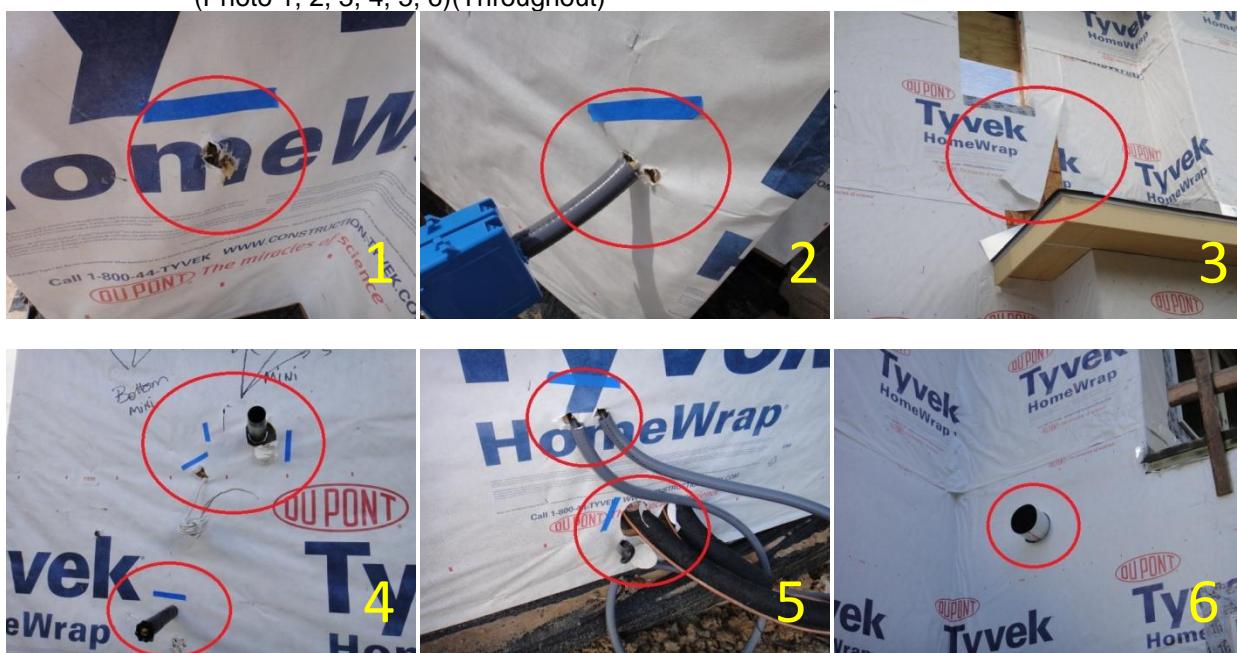
- Exterior building wrap / sheathing with unsuitable installation (tears, holes, water entry points, inadequate tape, missing tape, loose tape etc.) Hire qualified contractor to service/repair as needed (but not limited to):
(Photo 1, 2, 3, 4, 5, 6)(Throughout)

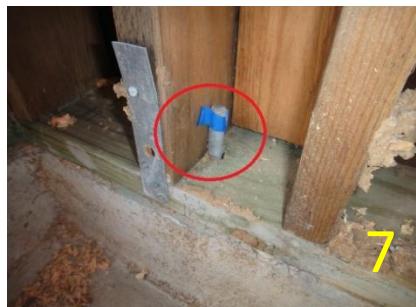
7

- Anchor bolts require tightening and or torque, install missing hardware (spacers and nuts) as needed. (Photo 7)(Throughout)
- Fire blocking missing to garage wall framing connections at: Electrical, vent pipes, ducts, gas lines, waterlines, plumbing, etc. (Photo 8)
- Support beams to rear porch and rear balcony appear to be not resting or sitting on top of wood columns/improperly supported, recommend installing joist hangers/L brackets/extra support as needed, client may consult structural specialist or engineer to evaluate structural integrity. (Photo 9, 10)
- Provide adequate support to roof ridge board braces on load bearing wall structures throughout, double the studs to wall framing beneath the roof braces to adequately support loads. (Photo 11-15)

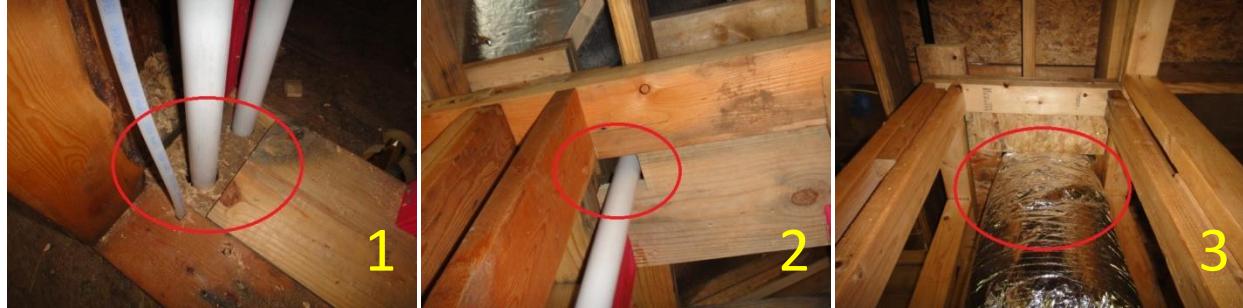
- Seal / fire block all penetrations through wood floor and ceiling connections (ducts, electrical, plumbing). (Photo 1, 2, 3)

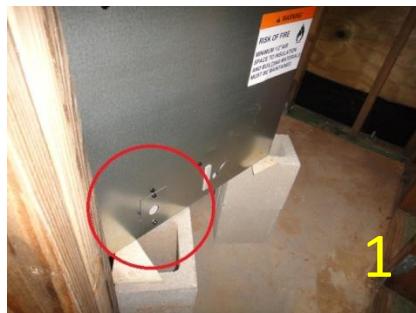
- 110V electrical branch wiring to fireplace was not present/missing.
(Photo 1)

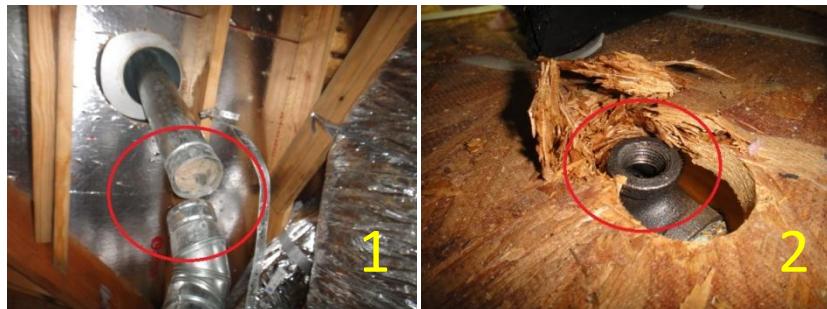
- Service/repair/secure the detached exhaust flue vent pipe to gas heating furnace.
(Photo 1)
- Gas branch lines to heating furnaces were incomplete and require repair.
(Photo 2)

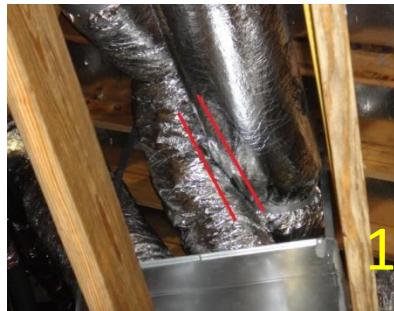
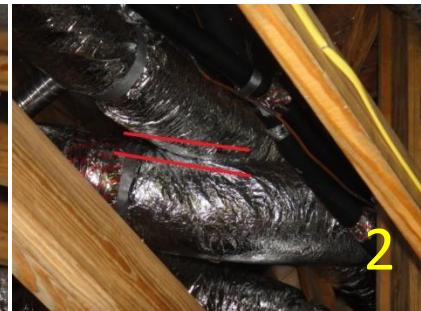
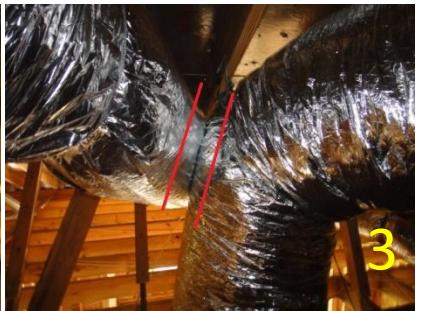
- Provide proper clearances between duct surfaces to prevent moisture build up between duct surfaces. (Photo 1, 2, 3)
- Observed return air register within kitchen (above refrigerator dock), current standards prohibit installing the return air register within kitchen area, service/relocate the return air register at this time. (Photo 4)

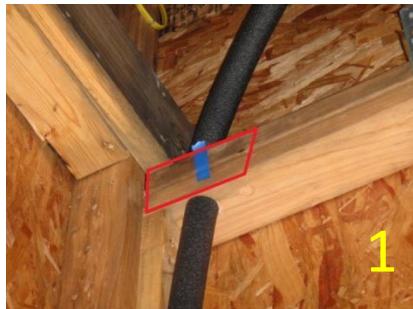
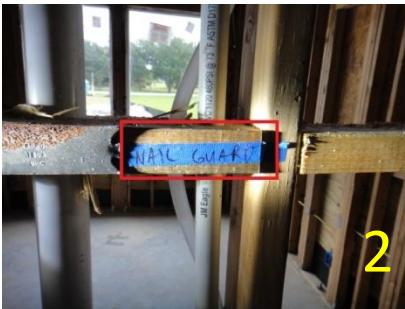
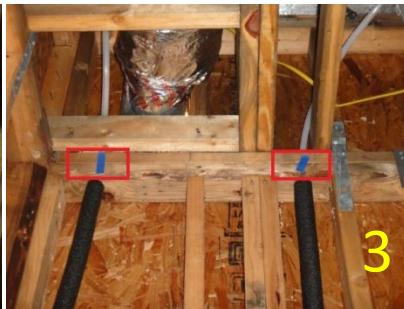
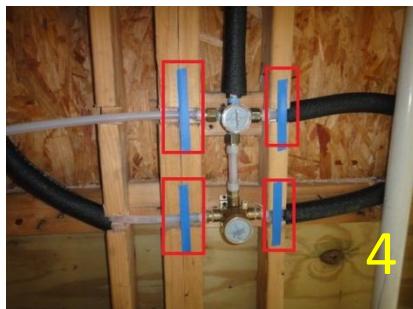
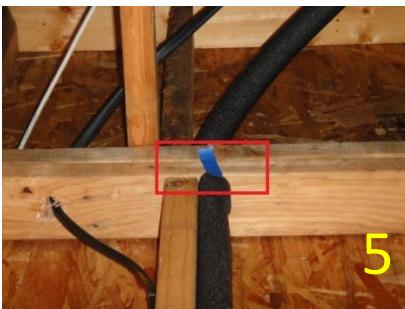
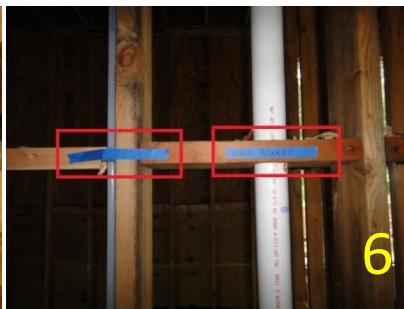
- Provide/install nail guards or nail plates to wall framing where water supply or plumbing lines pass through the framing, these nail guards protect the water supply or plumbing lines from driven screws or fasteners.
(Photo 1-9)

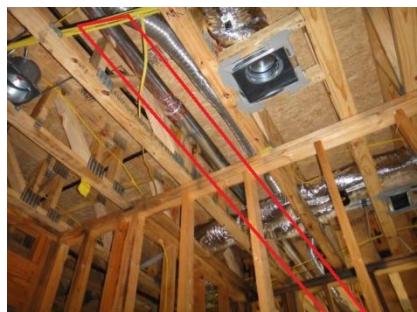
- Dryer vent observed with unsuitable installation or exceeds maximum length of 25', hire qualified contractor to service/repair as needed.
