**Property Inspections Performed by:
Mr. John Francis Casimiro
Professional TREC License #6570**

PROPERTY INSPECTION REPORT

FOUNDATION: SLAB-ON-GRADE FREE STANDING – MONOLITHIC (POST-TENSION)	
GUIDE: STORY: 2	HOUSE: RESIDENTIAL-SINGLE FAMILY DWELLING
BEDROOM: 6	BATH: 4.5 GARAGE: 3 CAR ATTACHED
YEAR BUILT: 2016	SQFT: 5300+/-
TIME: 11:00 AM	PRESENT: CLIENT - -
WEATHER: SUNNY	OUTSIDE TEMP: 80 DEGREES F.
UTILITIES: GAS: ON ELECTRICAL: ON	WATER: ON
Type: Final Phase Inspection

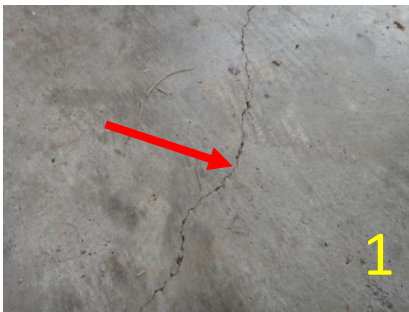
Monitor: Observed hairline cracks in the garage floor/slab; however, no deflection across these cracks could be felt or observed. No additional indicators of foundation movement or stress were observed. (Photo 1)

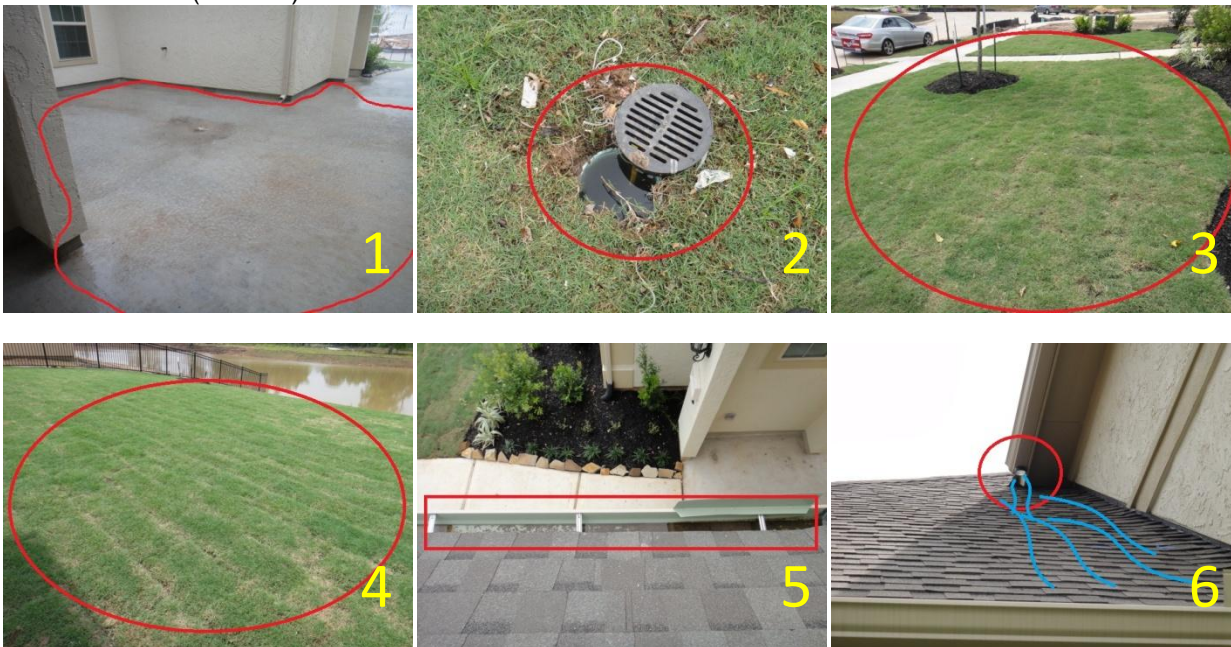
- Drainage to courtyard inadequate, observed excessive water on courtyard, water reaching up to front entry area, service/repair as needed.
(Photo 1)
- Courtyard drain pipe observed with unsuitable installation, loose covering, and eroding the soil around cover, recommend terminating near street curb/repair as needed.
(Photo 2)
- Grading and sod is unlevel, rutted, bumpy, damaged, and improperly installed throughout; service/repair as needed.
(Photo 3, 4)
- Observed standing water to gutter channels; repair / re-slope to properly drain rain water away.
(Photo 5)(Above front entry)
- Gutter downspouts were terminating onto roof covering in several areas, this can cause stains on roof covering, possible roof leaks, etc. service/repair as needed.
(Photo 6)

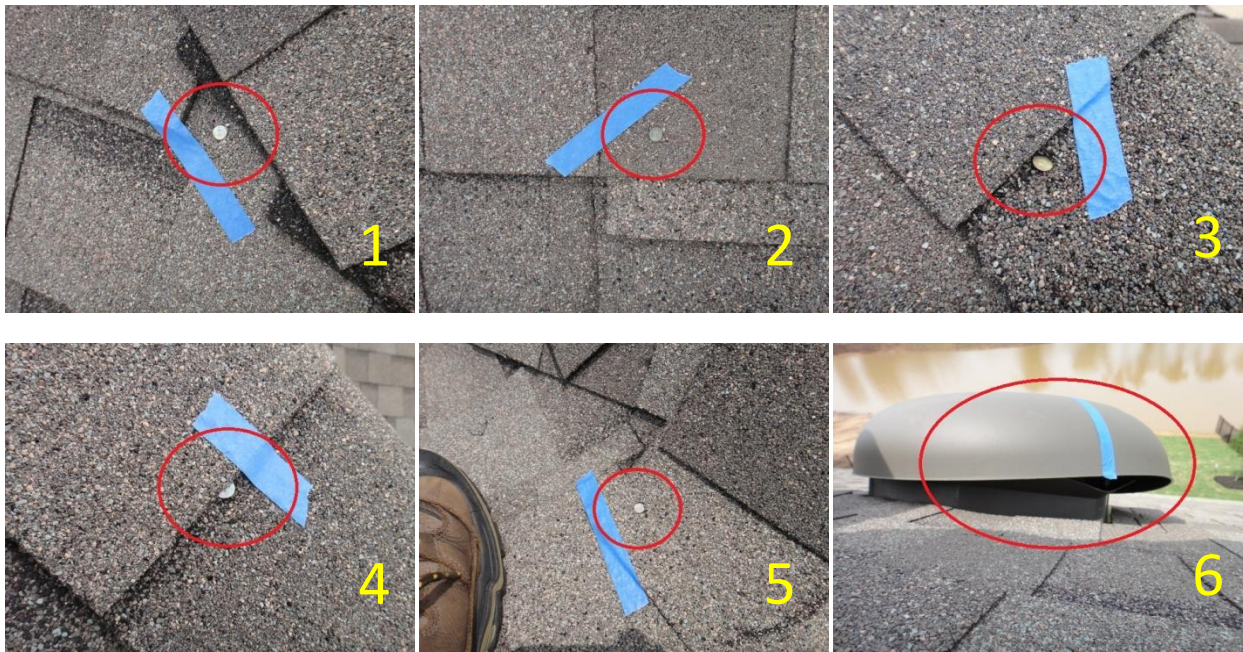
- Exposed nail heads (shallow nails) on roof covering surfaces require repair/sealant/caulk. (Photo 1, 2, 3, 4, 5)(Throughout)
- Roof vent cap at rear (2nd story) was uplifted/damaged, service/repair as needed. (Photo 6)

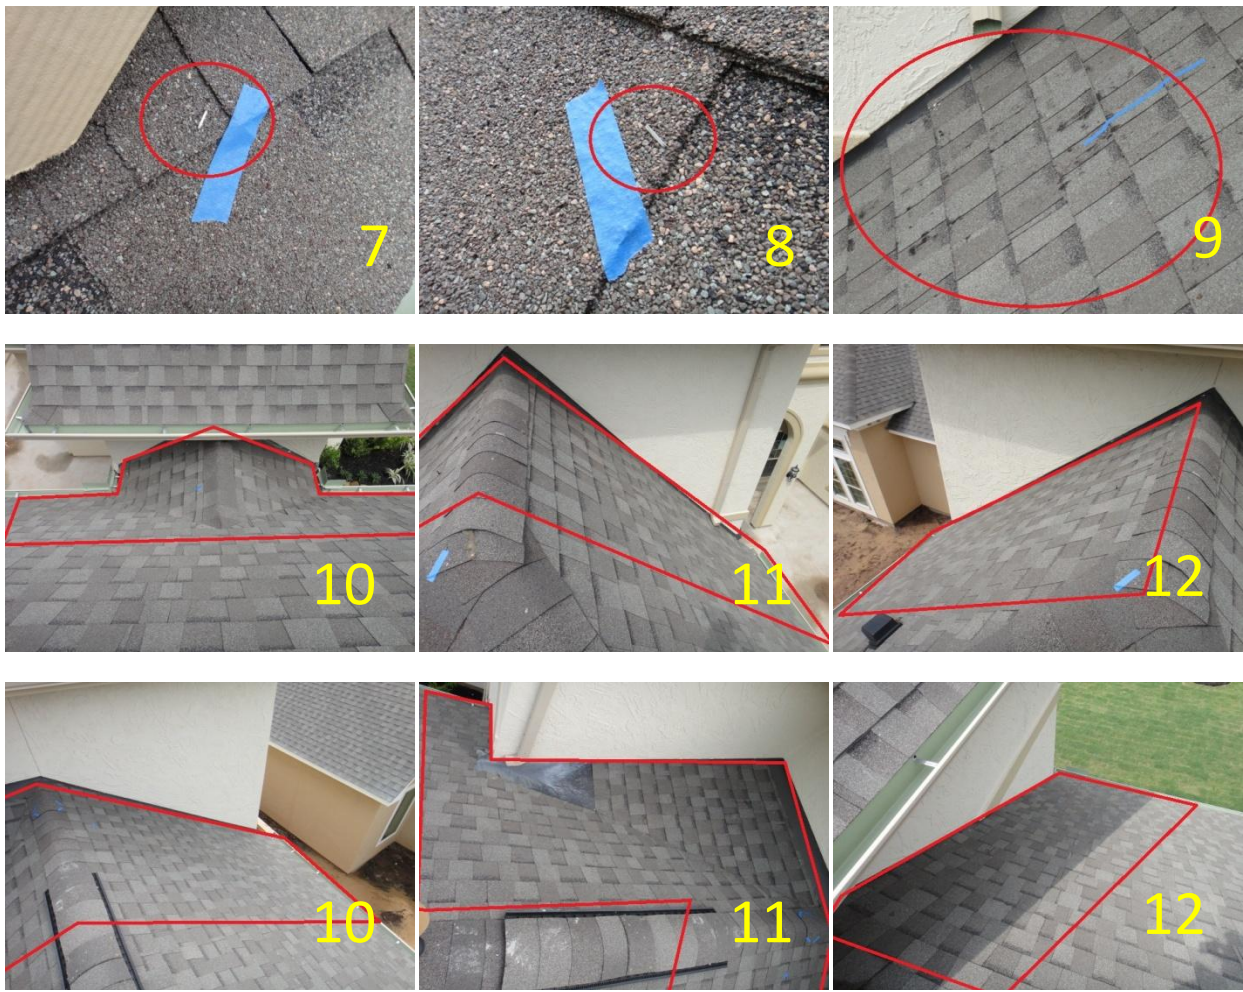
- Observed staples to roof covering adjacent to stucco wall structures throughout, these damaged shingles can be a water entry point and or void roof manufacturer's warranty. Service-replace damaged sections entirely at this time.
(Photo 7, 8, 9, 10, 11, 12)(Throughout)

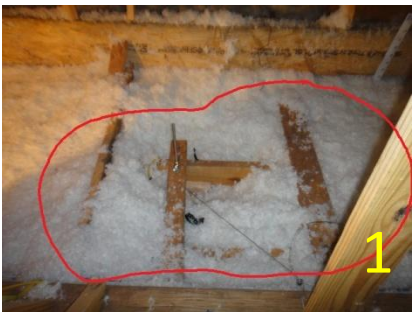
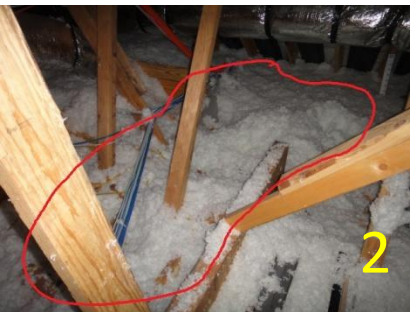
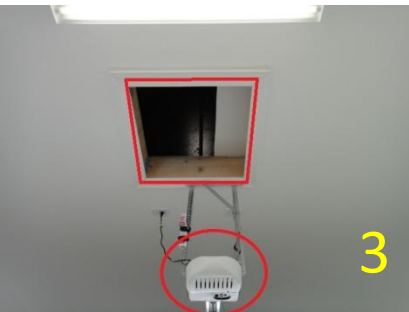
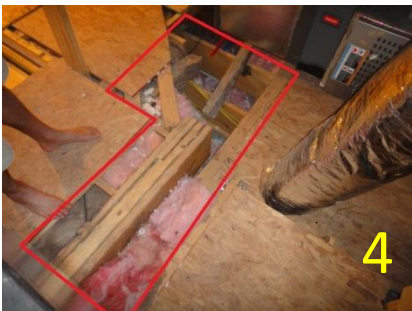
- Attic floor insulation thickness inconsistent and inadequately installed, service/repair as needed. (Photo 1, 2)(Main attic crawlspace)
- Attic access within 2 car garage observed with unsuitable installation, attic access was very difficult due to clearances with garage door motor, service/repair/re locate the attic access away from the garage motor. (Photo 3)
- Mechanical floor decking observed with unsuitable installation, missing, or inadequately installed, service/repair as needed. (Photo 4)

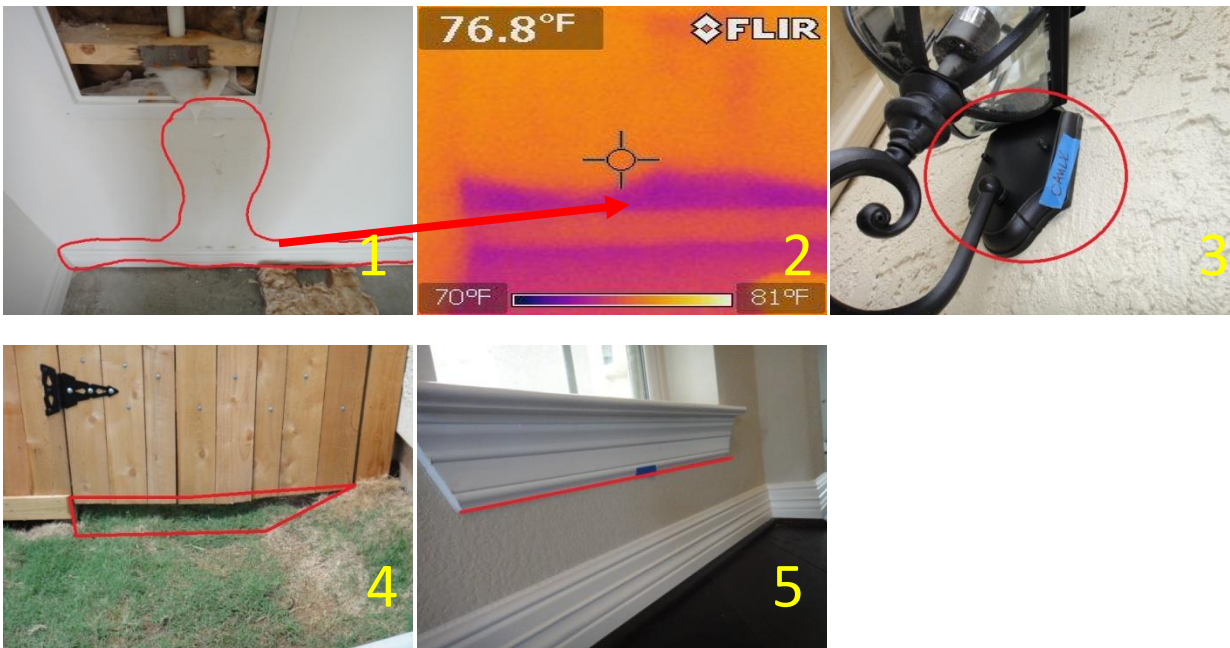
- Observed water damage to drywall sheetrock below the PEX water manablock water center within single car garage, replace/repair the sheetrock as needed. Thermal imaging and non invasive moisture meter reveals moisture to sheetrock, service/repair at this time.
(Photo 1, 2)
- Seal / caulk exterior light fixtures at wall connections.
(Photo 3)
- Observed large gap between wood fence gate at grading connection, service/repair as needed.
(Photo 4)
- Seal/caulk the drywall/window apron trims as needed.
(Photo 5)

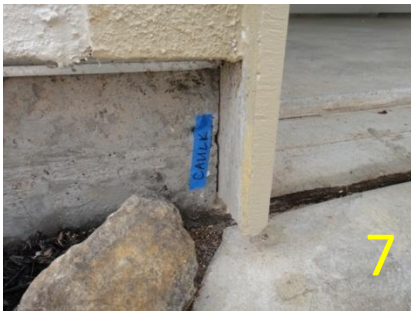
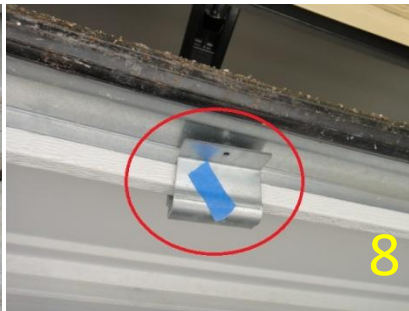
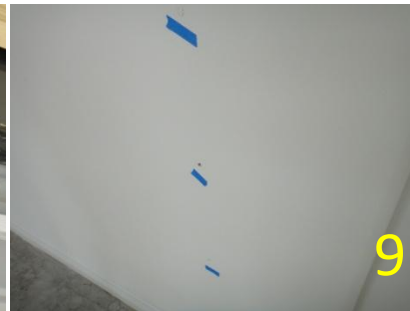
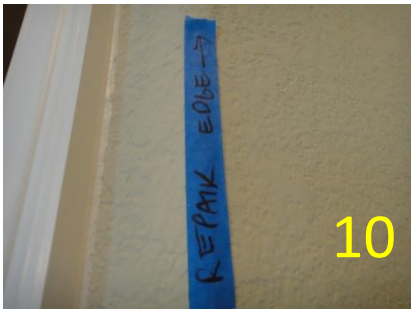
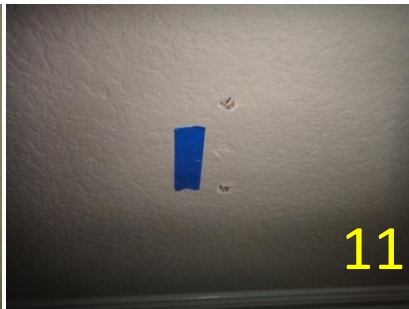
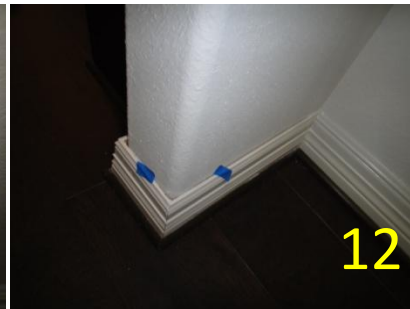
- Service/repair all cosmetic deficiencies throughout as indicated with blue tape. (Example: Paint scuffed, separations to joints, drywall texture lacking/excessive, nicks, scratches, bruises, paint mismatched, missing caulking to joints, workmanship defects (Photo 7, 8, 9, 10, 11, 12)
- Interior drywall sheetrock throughout observed with unsuitabe installation and or lacks workmanship/improperly floated, texture inconsistent, cracks, separations, trim joints separating, nail pops, etc. service/repair as needed.

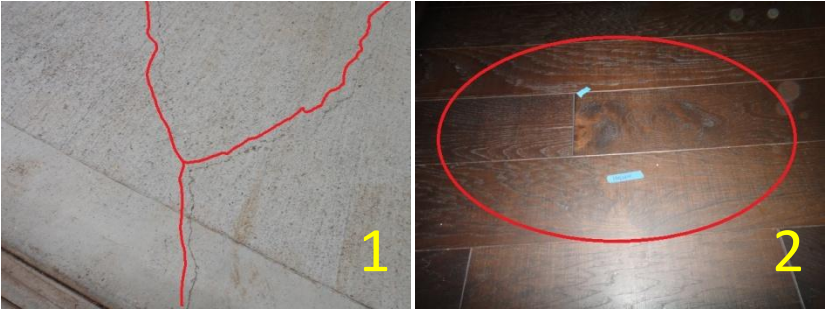
- Cement driveway, sidewalk, and walkways observed with cracks / unlevel.
(Photo 1)(Repair 3 slabs)
- Finished wood flooring with unsuitable installation: Gaps, damaged, splits, hollow, etc. Service/repair as needed.
(Photo 2)(Throughout)
- Hire qualified contractor to service/repair the ceiling sheetrock throughout, observed unsuitable installation, bumps, deflection, improper float job, visible lines, cracked joint tapes, texture inconsistencies, etc.

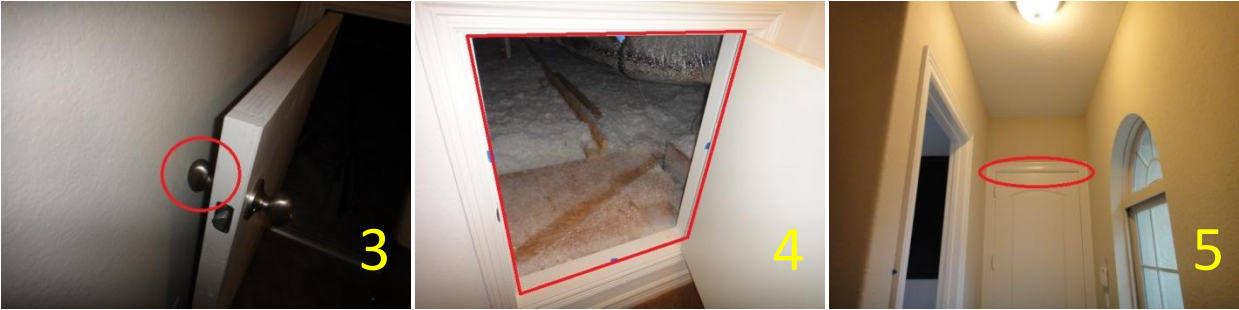
- Provide/install doorstoppers to entry doors as needed.
(Photo 3)(Attic closet door)
- Provide weather stripping to attic closet entry door and two car garage entry door.
(Photo 4, 5)

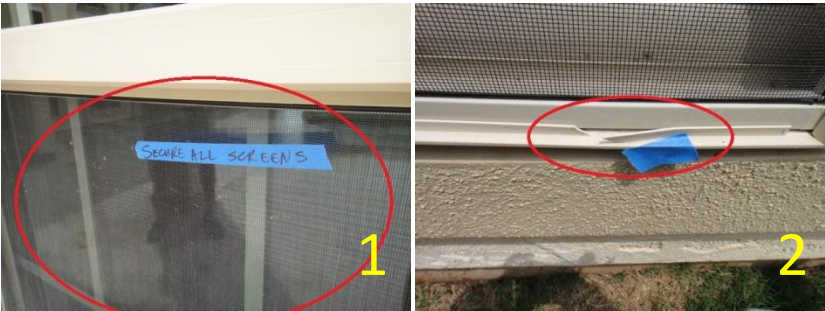
- Service, secure, repair damaged window screens/screen rail.
(Photo 1, 2)(Throughout)

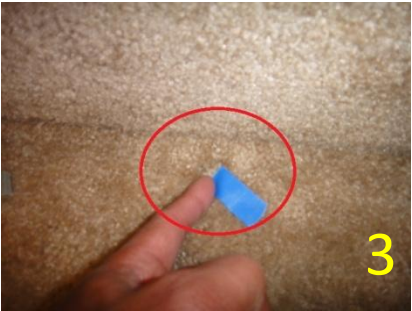
- Carpet tab nails to stairway threads were protruding and felt when stepped on, service/repair as needed.
(Photo 3)

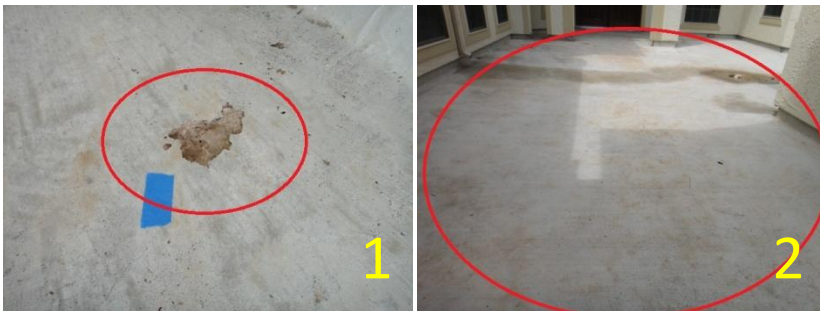
- Service/repair/re-surface the cement flooring surfaces to garage, rear porch, entry walkway, etc. Observed stains, discoloration, spilled/hardened mortar, chips, damages, cosmetic defects, etc. (Photo 1, 2)(Throughout)

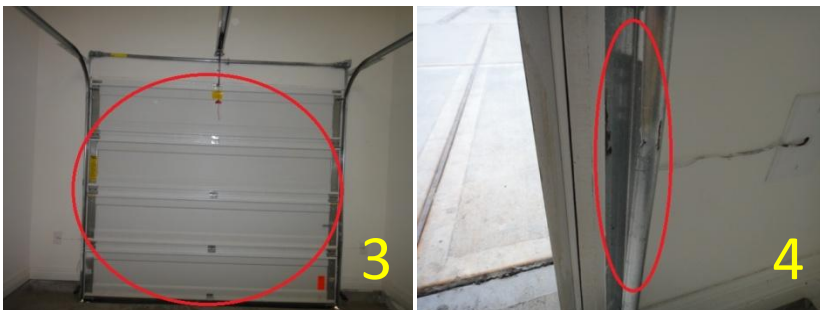
- Service/repair/adjust the noisy garage door operation. (Photo 3)
- Hardware, rollers, railings, springs, etc. require service /repair. (Photo 4)(Bent rail)

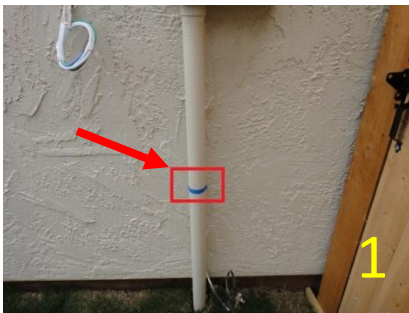
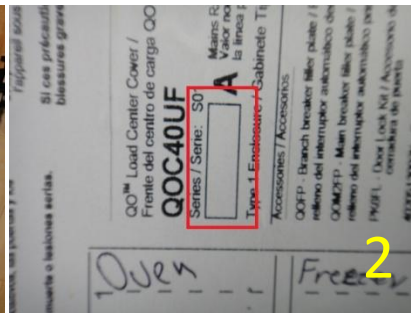
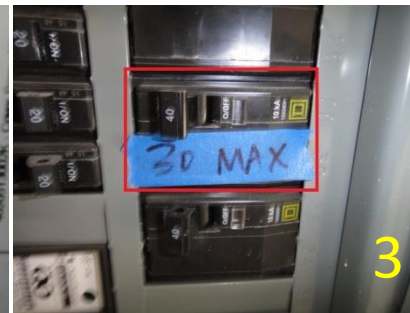
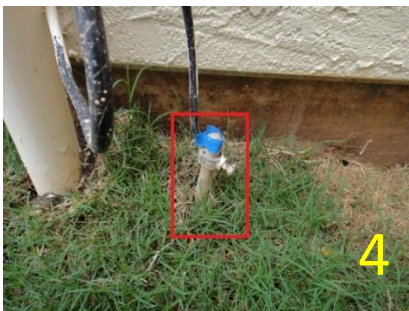
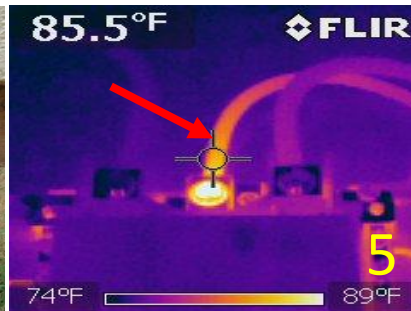
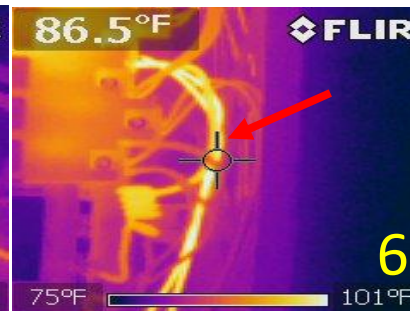
- PVC conduit below electric meter box is missing fastener at wall connection. (Photo 1)
- Clearly mark / label all breakers within electric panel box. (Photo 2)(Main amp rating not labeled)
- AC breaker is oversized within electric panel box; the AC manufacturer's suggested maximum amperage was exceeded, service/repair as needed. (Photo 3)
- Grounding rod was exposed and improperly driven, the grounding rod shall be buried or flush with grading, service/repair as needed. (Photo 4)
- Thermal imaging reveals temperature anomaly to main breaker service conductor and exterior lights breaker electrical branch wiring, further inspection reveals improperly torque fasteners to the main service conductors, service/repair as soon as possible. (Photo 5, 6)

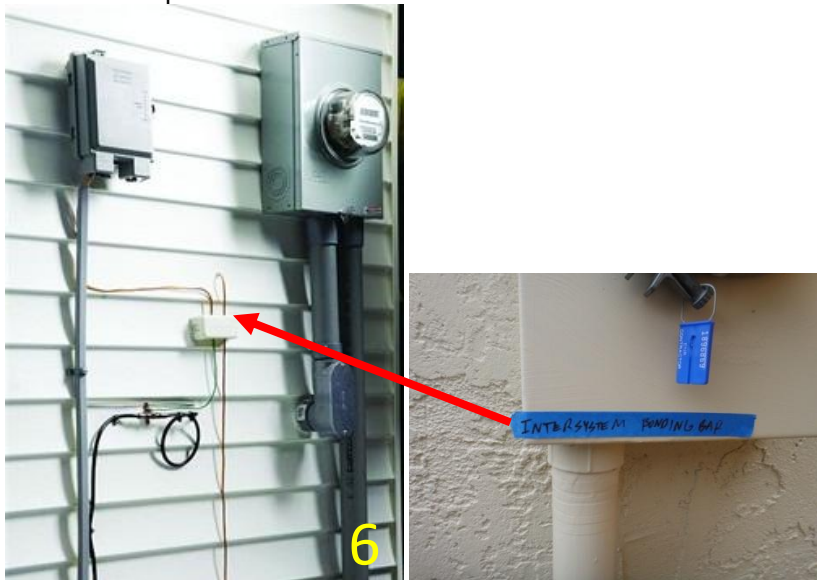
Example Photo:

- An intersystem bonding bar is required by the National Electrical Code and the IRC. This is where the connections of the bonding conductors for water pipes, gas pipes, communication systems, CATV, satellite, and low voltage systems are required to be made.
(Photo 6)

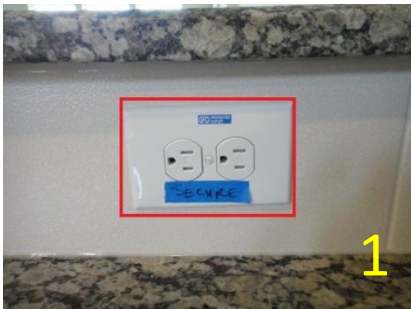
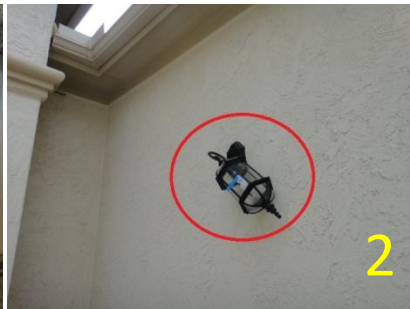
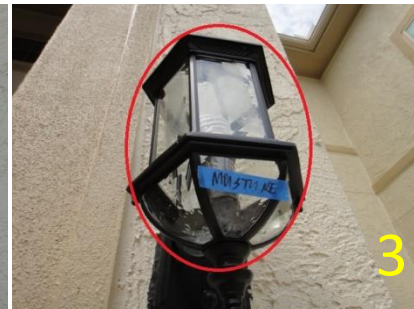
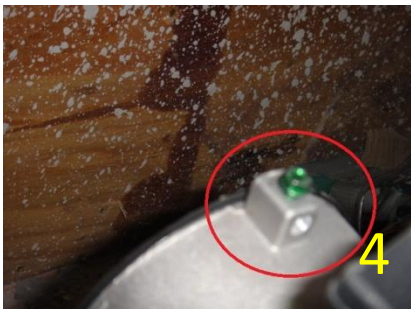
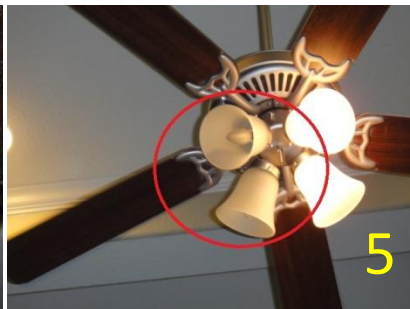
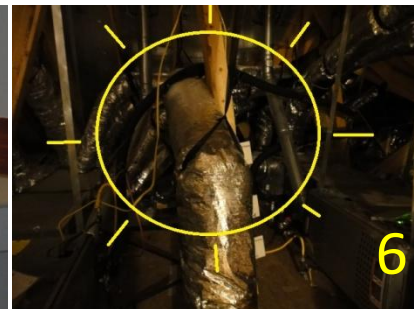
- Service/align/secure the misaligned and or loose wall outlets as needed throughout. (Photo 1)
- Service/secure/align light fixtures as needed. (Photo 2)
- Observed moisture/condensation within exterior light fixtures, service/repair as needed. (Photo 3)
- Jet tub motor ground wire was missing/not present, service/repair as needed. (Photo 4)
- Service/replace inoperable light bulbs/fixtures as needed throughout. (Photo 5)
- Install additional light fixture to mechanical area within main attic crawlspace. (Photo 6)

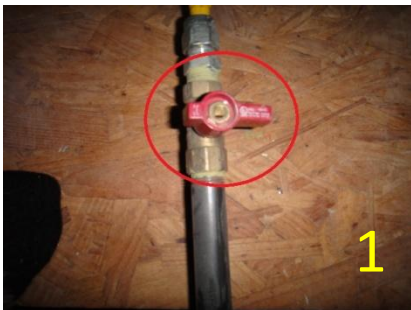
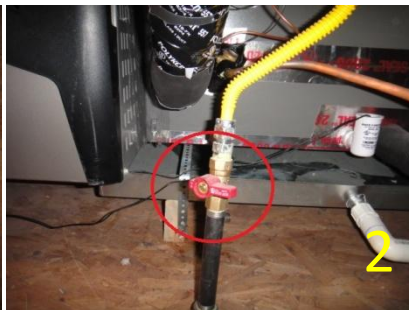
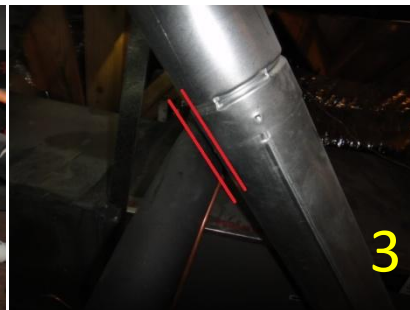
- Gas heating furnace inoperable, hire professional technician to evaluate/repair as needed. (Photo 1, 2)(Gas valves OFF)
- Ensure proper clearances between hot exhaust pipe and combustible materials. This is a possible safety/fire hazard. (Photo 3)

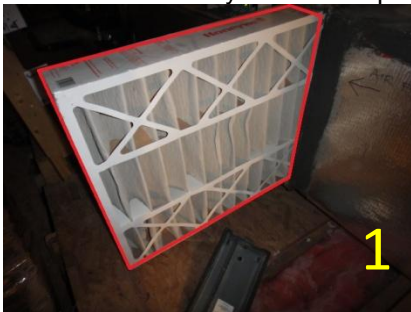
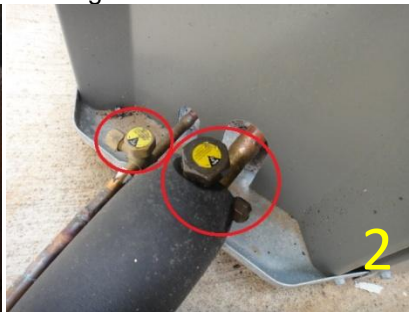
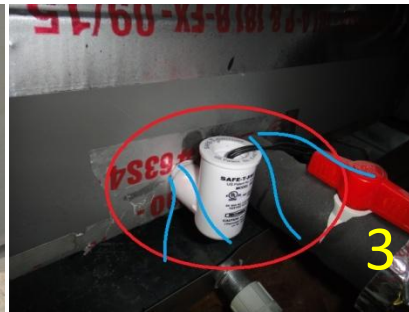
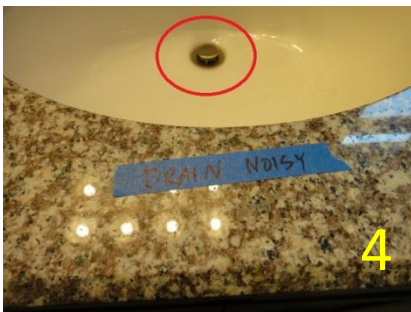
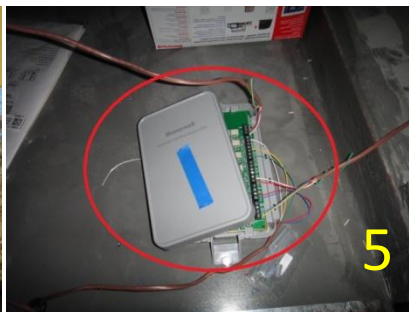
- Service/replace the dusty/dirty media air filters within HVAC unit. (Photo 1)
- Tighten / torque the AC refrigerant valve caps as needed. (Photo 2)
- Seal the AC lines to HVAC casing connections; observed air leakage at connections. (Photo 3)
- Sink drain noisy, observed AC condensate drain tied to this drain line, service/repair as needed. (Photo 4)
- Secure/repair the loose covering to AC control module. (Photo 5)
- AC cooling system did not function / cool as intended at time of inspection; differential temperature readings did not attain the required 15-20 Degrees Fahrenheit differences. Hire qualified technician to fully evaluate/repair cooling unit.

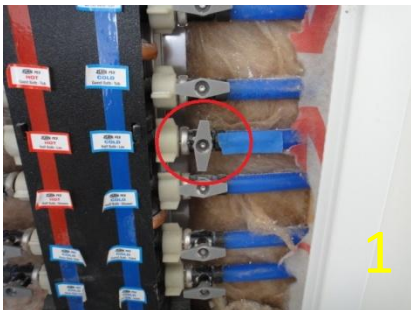
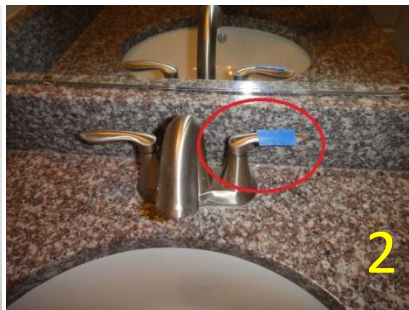
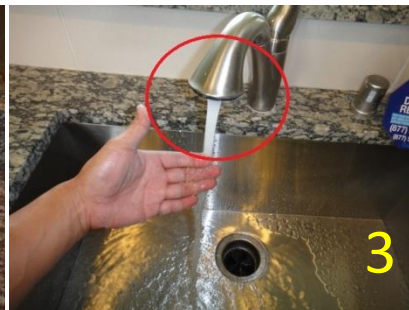
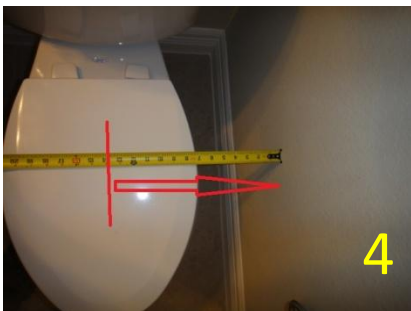
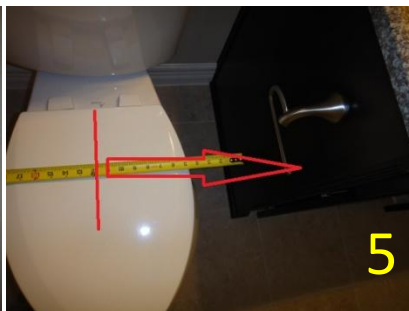
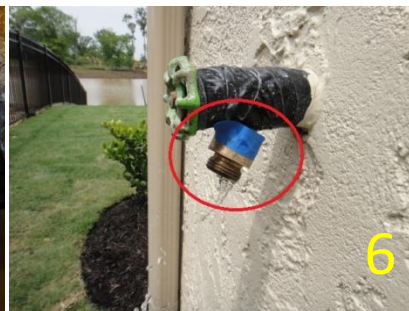
- No water present to sink fixture, service/repair as needed. (Photo 1, 2)(Shutoff valve off)

- Service/repair the damaged anti siphon device at left rear corner. (Photo 6)
- Water meter housing damaged, missing cover, damaged cover, unlevel, etc.
- Hot water takes a very long time to heat up, this was observed to all sink/tub/shower fixtures, service/repair as needed. (Photo 3)

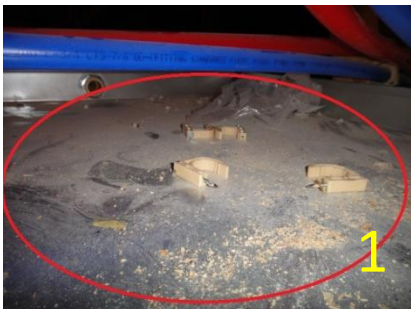
- Remove debris/insulation from safety drain pans.
(Photo 1)

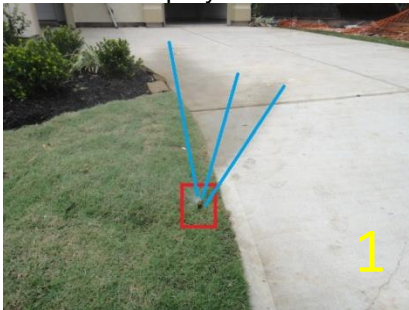
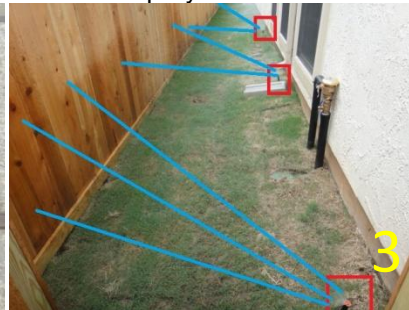
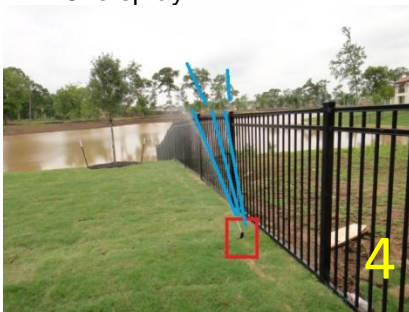
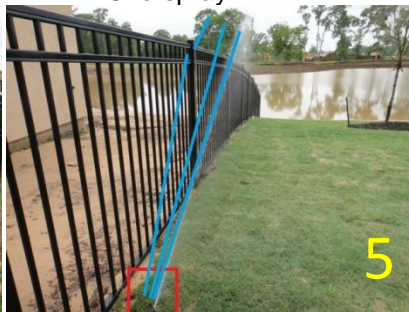
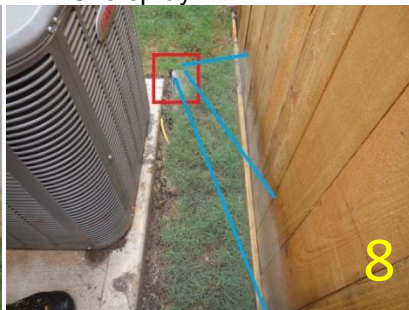
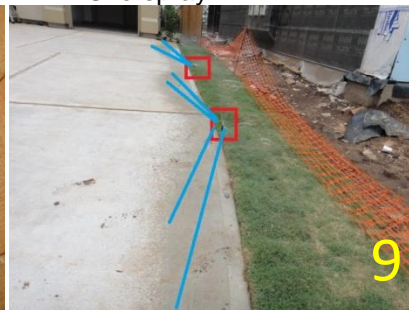
- Hire qualified irrigation technician to service/repair/replace/adjust sprinkler system at this time:
- -Sprinkler heads spraying walls, driveways, streets, walkways, fence, AC units, and or damaged/leaking sprinkler heads, partially blocked/buried sprinkler heads, kinked drip irrigation hoses, leaning, improperly secured, low water pressure, inoperable zones
(Photo 1, 2, 3, 4, 5, 6, 7, 8, 9)

Overspray

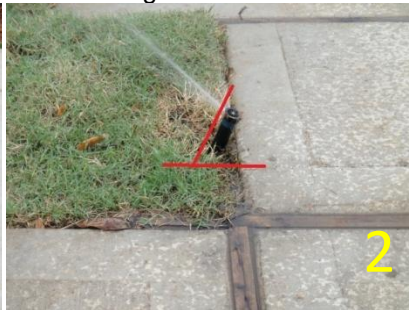
2

Leaning

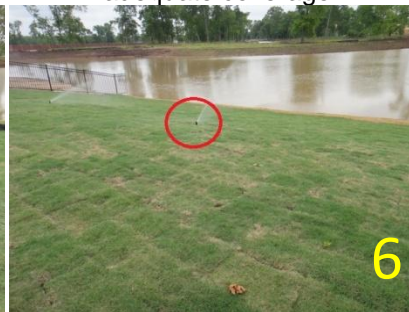
6

Inadequate coverage

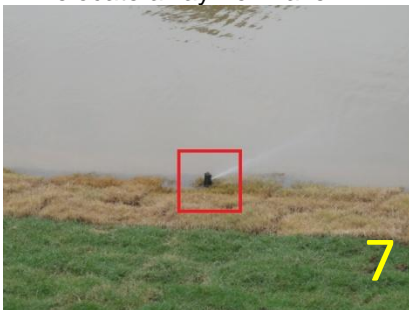
7

Relocate away from lake
